# **Fusion of Information from Optical, Thermal, Multispectral Imagery and Geologic/Topographic Products to Detect Underground Detonations**

Autometric, Incorporated  
5301 Shawnee Road  
Alexandria, Virginia 22312-2312

12 February 1992

## **Phase II SBIR Annex 1 - Ground Truth Report**

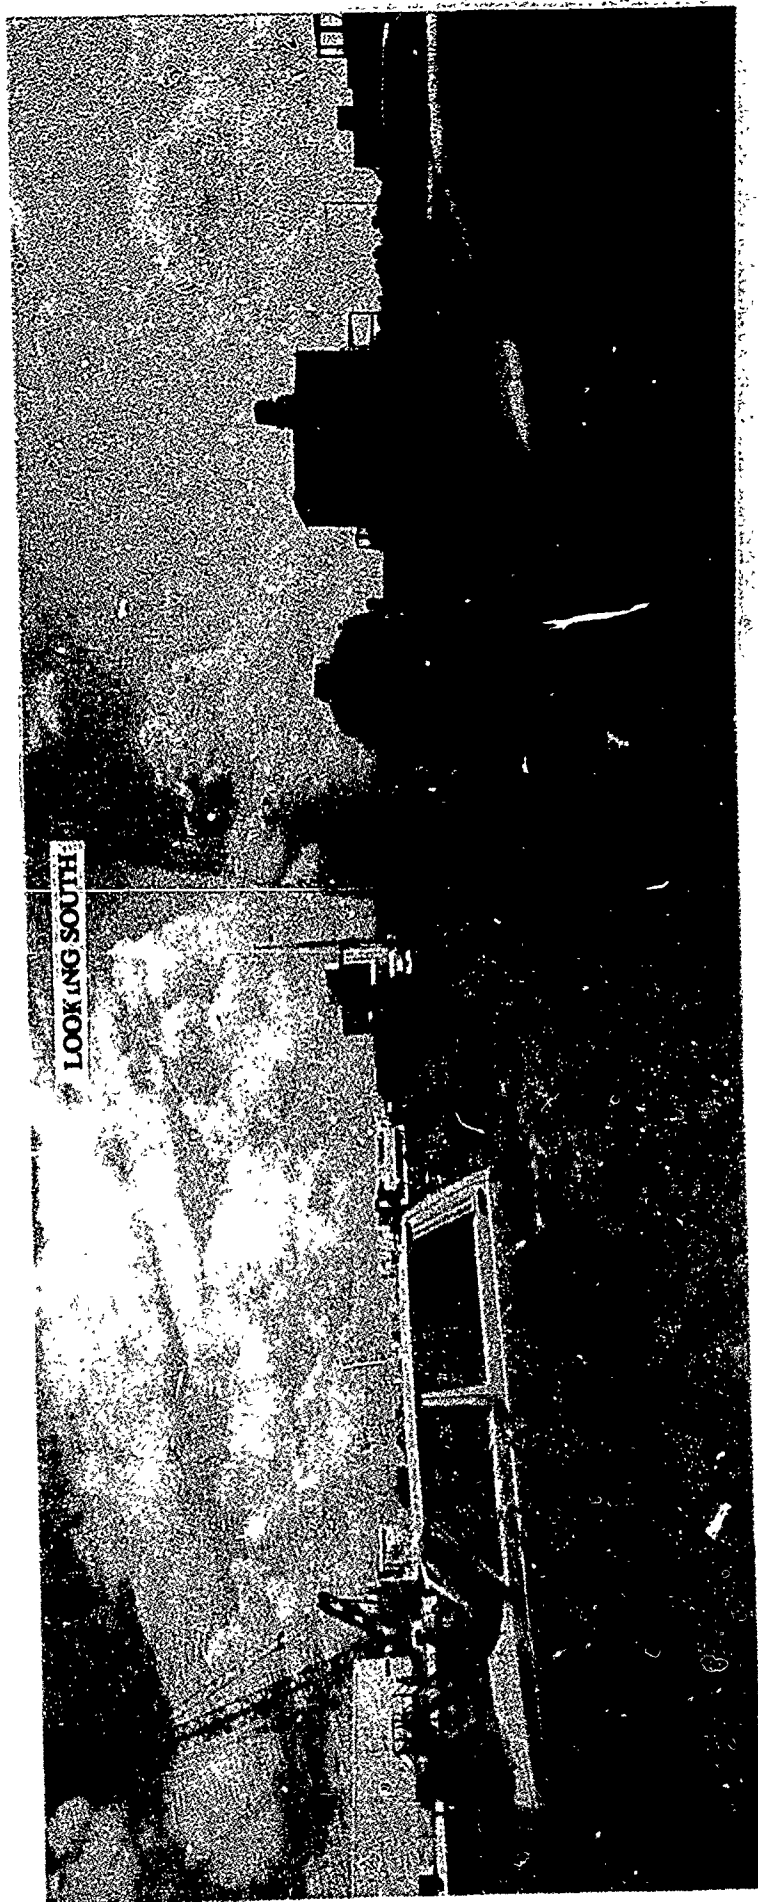
Figure II-6

**FIGURE II-6 GROUND PANORAMIC (360°) FROM THE INSTRUMENTATION AREA, PRE-DETONATION**

This series of ground photographs was taken one day before the scheduled test. The position is in the open area between the westernmost cluster of trailers and the continuation of the line. The pan begins looking at the GZ to the north, then west to the edge of the trailer line, and along the trailer line looking to the east. The GZ can barely be discerned as a white target board near the center of the large bulldozed flat area.

To the south and west of the GZ is a small square mobile trailer containing a small dish antenna and a video camera. A mobile generator is also parked adjacent to the trailer. This equipment was moved shortly after these photos were taken and do not show up in the helicopter images.

To the west of the photographers position is a cluster of trailers with SIMULATOR-3 in the foreground. Since these images will be compared to post detonation images, note particularly the condition of the soil around the trailers, the absorbing foundation pillars protecting SIMULATOR-3, and the small collection of rocks in the foreground. Note also that each trailer and open equipment platform is mounted several feet above ground level.

Looking toward the southeast, several of the other trailers are observed. Note all the vehicular traffic and the position of the tall crane. Note also the upright red and white vehicle barrier protecting a line of cables.

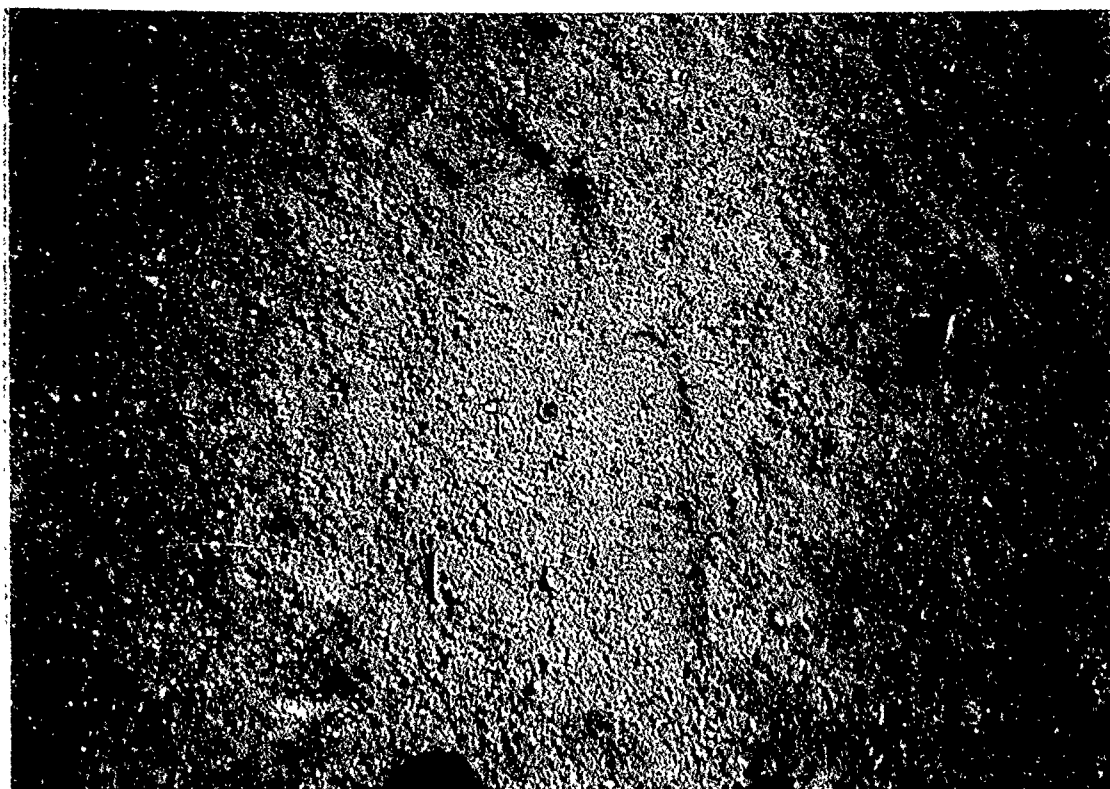
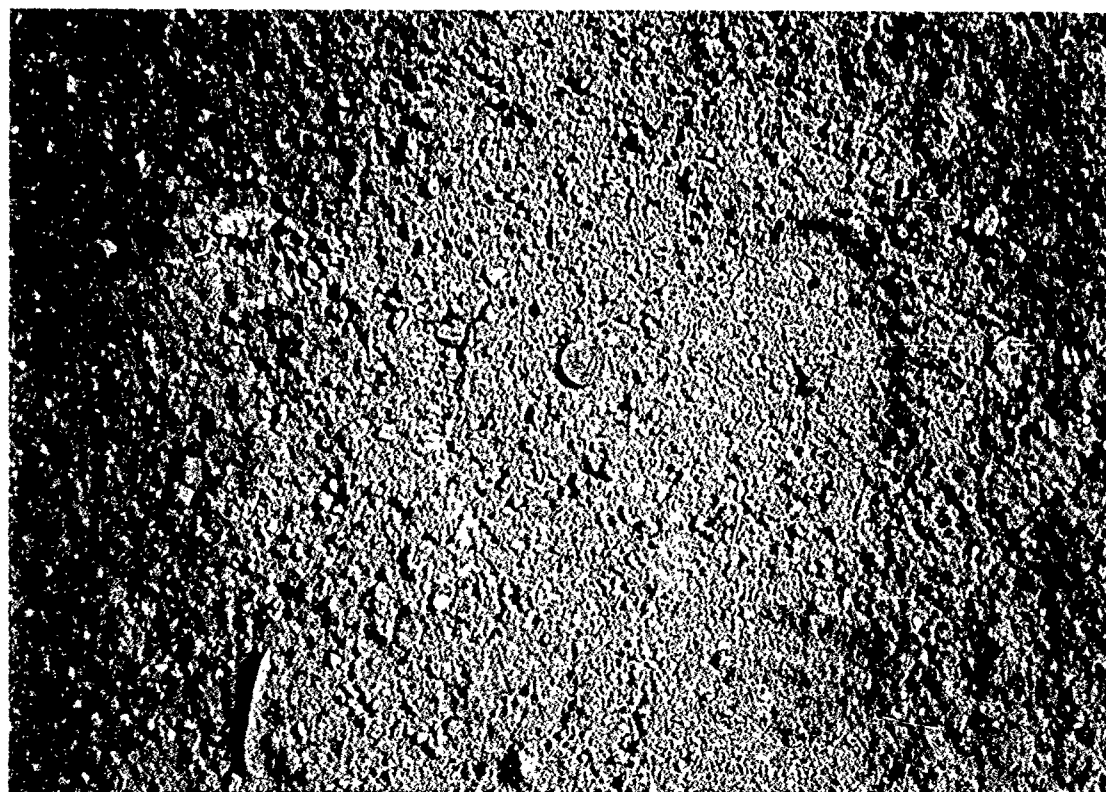
Figure II-20

FIGURE II-20 CLOSE-UP VIEW OF GROUND INSTRUMENTATION AREA, PRE-DETONATION

The first two images of the ground surface near the trailer area, taken prior to the detonation, depict the homogeneity of the soil texture, and its sponge-like characteristics evidenced by the footprints in the images. The fine grained material does not appear to be similar to the coarser textured surrounding soil and may be the spoil from the drill site. The spectral characteristics of this soil should differ from that of the surrounding area.

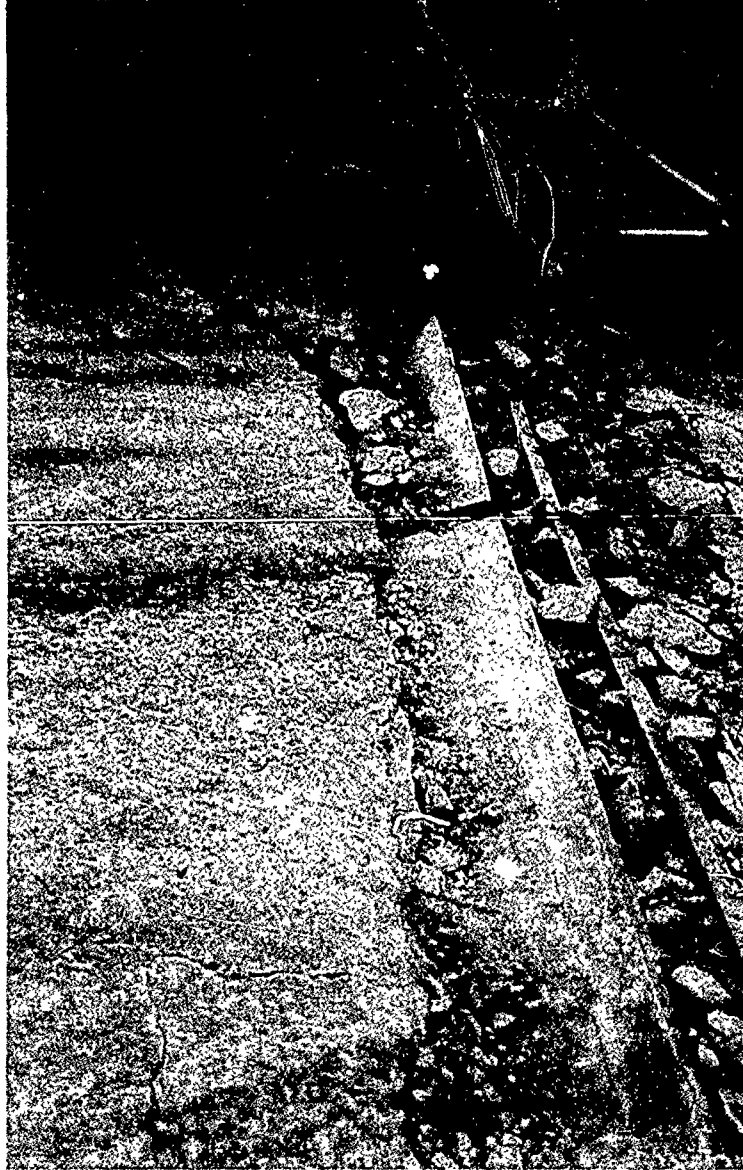
Figure II-21

**FIGURE II-21 CLOSE-UP VIEW OF GROUND AT INSTRUMENTATION AREA, POST-  
DETONATION**

The next three images were taken after the test detonation, and documents the surface changes that have occurred due to the seismic movements of the underground blast. A comparison with the other close views of the soil before the test indicates that some of the fine grained material has disappeared and the coarser textured compacted underlying soil is now visible. An irregular network of shallow cracks is evident breaking up the compacted "crust" of the surface material, but not fracturing individual rocks or pebbles. Few macro-changes have occurred, although there is some indication of mounding near the GZ, and the GZ target is not visible. The underlying soil does appear to have the same, but slightly darker, color as the initial top-soil.
